Multnomah County Willamette River Bridges Capital Improvement Plan

Project Summary Information: Bent Cap Rehabilitation - Approach Spans							
Bridge Names(s):	Morrison	Project ID#:	BUN-MO-10	Project Status:	In Progress		
Project Rank:	8	Primary Category of Work	Structural	Performance Attribute Total Score	13	Importance Score	TI-1 9.66
Logical Grouping Project ID #'s:	MO-STRUCT-05						
Bridge Num and Names(s):	02758B W Morrison Br Conn over Hwy 1W (Front Ave) & Park [Morrison] ; 08589Y SE Yamhill St Ramp over Hwy 1 & Conn (Morrison Int) [Morrison] ; 08589 Willamette R & Hwy 1, SE Morrison St (Morrison Int) [Morrison]; 02758A SE Belmont St over Hwy 1 & Conns (Morrison Intchg) [Morrison]

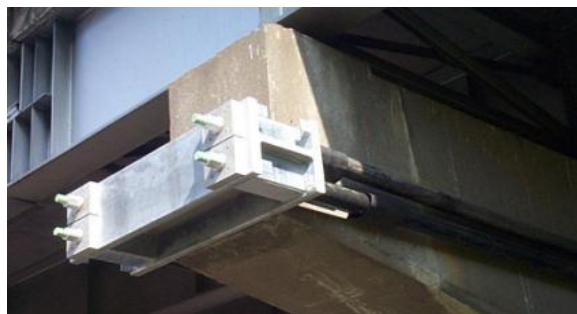
Portions of the Morrison Bridge West and East Approach bent caps are exhibiting signs of deterioration. Multiple bent caps show signs of concrete spalling with exposed reinforcing steel. Based on the observed condition and review of available existing documentation, it is anticipated that pier cap strengthening will be required for some of the bent caps for these bridge approaches.

Concrete spalls will be repaired and patched, and bent cap strengthening solutions will be applied for all bent caps where it is determined through analysis that load carrying capacity less than required for current design vehicle loading.
